# Manhole Inspection Summary

Manhole # S05EE1021MH

Insp Date: **12/23/08 2:35 PM**

**Location** Address: **3903 OAKFORD AVE**

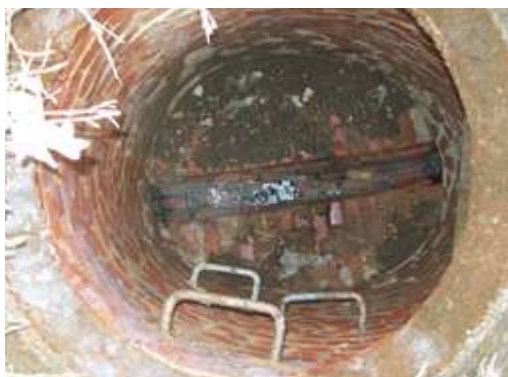
Top View

DEBRIS ON CHANNEL AND BENCH.

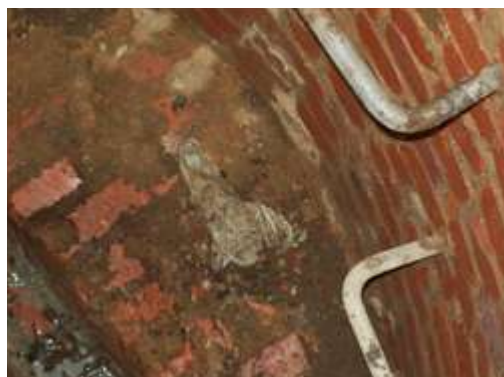
Defect 2

**Surcharge** ☒ **Evidence Of Surcharge** Depth: **5.** (ft.) ☐ Active Surcharge Present

EVIDENCE SURCHARGE

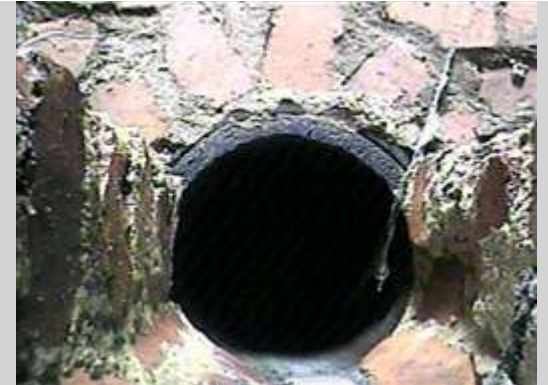
12 O'Clock Outflow

8 in. Circular Gravity Sewer  
Pipe Out @ 12 O'Clock

Pipe Height: (in.) Direct  
Pipe Material: **Clay** ☐ Pipe Lined  
Invert Depth: **6.55** (ft.) Flow Characteristics: **Slow**  
Deposits: ☒ None ☐ Mud ☐ Sludge ☐ Debris ☐ Grease  
Silt Depth: (in.) Deposits Extent:  
Infiltration: **None** Pipe Seal Cond: **Sound**

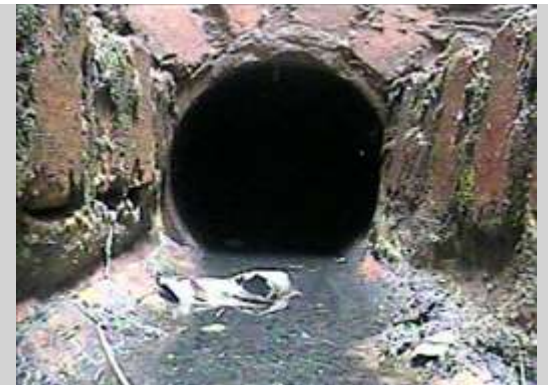
6 O'Clock Inflow

8 in. Circular Gravity Sewer  
Pipe In @ 6 O'Clock

Pipe Height: (in.) Direct  
Pipe Material: **Clay** ☐ Pipe Lined  
Invert Depth: **6.49** (ft.) Flow Characteristics: **Slow**  
Deposits: ☒ None ☐ Mud ☐ Sludge ☐ Debris ☐ Grease  
Silt Depth: (in.) Deposits Extent:  
Infiltration: **None** Pipe Seal Cond: **Sound**
